DEPARTMENT OF TRANSPORTATION

Contract #: 04-0120F4Cty: SF/Ala Rte: 80 PM: 13.2/13.9File #: 69.28**WELDING INSPECTION REPORT****Resident Engineer:**Siegenthaler, Peter**Address:** 333 Burma Road**City:** Oakland, CA 94607**Report No:** WIR-024773**Date Inspected:** 08-Jun-2011**Project Name:** SAS Superstructure**OSM Arrival Time:** 1900**Prime Contractor:** American Bridge/Fluor Enterprises, a JV**OSM Departure Time:** 700**Contractor:** Zhenhua Port Machinery Company, Ltd (ZPMC), Changxing Island **Location:** Shanghai, China**CWI Name:** See below**CWI Present:** Yes No**Inspected CWI report:** Yes No N/A**Rod Oven in Use:** Yes No N/A**Electrode to specification:** Yes No N/A**Weld Procedures Followed:** Yes No N/A**Qualified Welders:** Yes No N/A**Verified Joint Fit-up:** Yes No N/A**Approved Drawings:** Yes No N/A**Approved WPS:** Yes No N/A**Delayed / Cancelled:** Yes No N/A**Bridge No:** 34-0006**Component:** OBG Components**Summary of Items Observed:**

OBG Trial Assembly Area

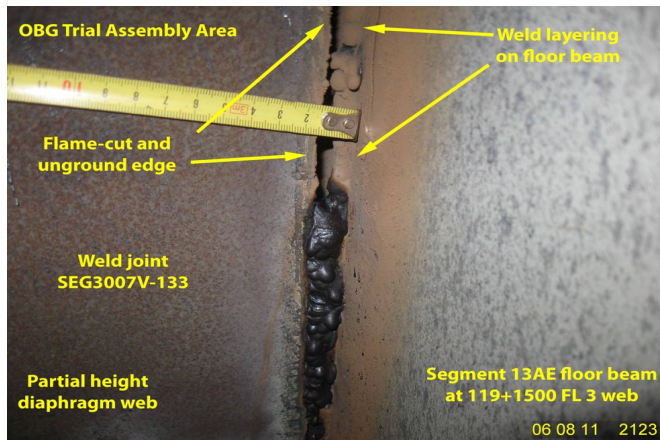
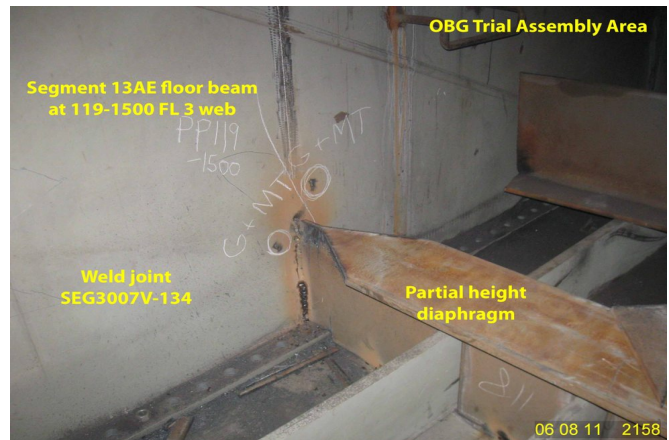
SMAW welding of weld joints SEG3007V-133, 134 located on PCMK OBG 13AE, FL3 area. Welder was identified as 049769. QC was identified as QC1. No QC personnel were present in the area to be monitoring the welding operation and recording data. When this QA Inspector informed QCA1 and QCA2 of the welding operation, neither was aware of it. No weld variables had been recorded by QC personnel. The welding was being performed on a Seismic Performance Critical Member (SPCM) Floor Beam to fill the gap of a flame cut between it and the Partial Height Diaphragm. The flame cut was located at the designed joint SEG3007V-133, 134. No joint preparation was performed to the rough flame cut edges prior to welding. No approved weld repair procedure was observed onsite during this welding operation. The root opening was measured between 12mm to 23mm. This non conforming repair was located 13AE Floor Beam panel point (PP) 119-1500 at the FL3 Partial Height Diaphragm web. Weld joints at SEG3007V-133, 134 were designed as 8mm fillet welds. ZPMC Quality Control (QC) and ABF QC were unaware of this work and welding being performed inside their work stations. This QA Inspector generated an Incident Report concerning the above noted issues. See that report and photos below for more information.
